NASA-MSC-G-R-65-2
SUPPLEMENTAL REPORT 7

EVALUATION OF VELOCITY ERROR
IN IMU DURING ASCENT PHASE
(GEMINI 2 and GEMINI 3 MISSIONS)

REPORT B984

SUBMITTED UNDER Contract NAS 9-170 - Project Gemini

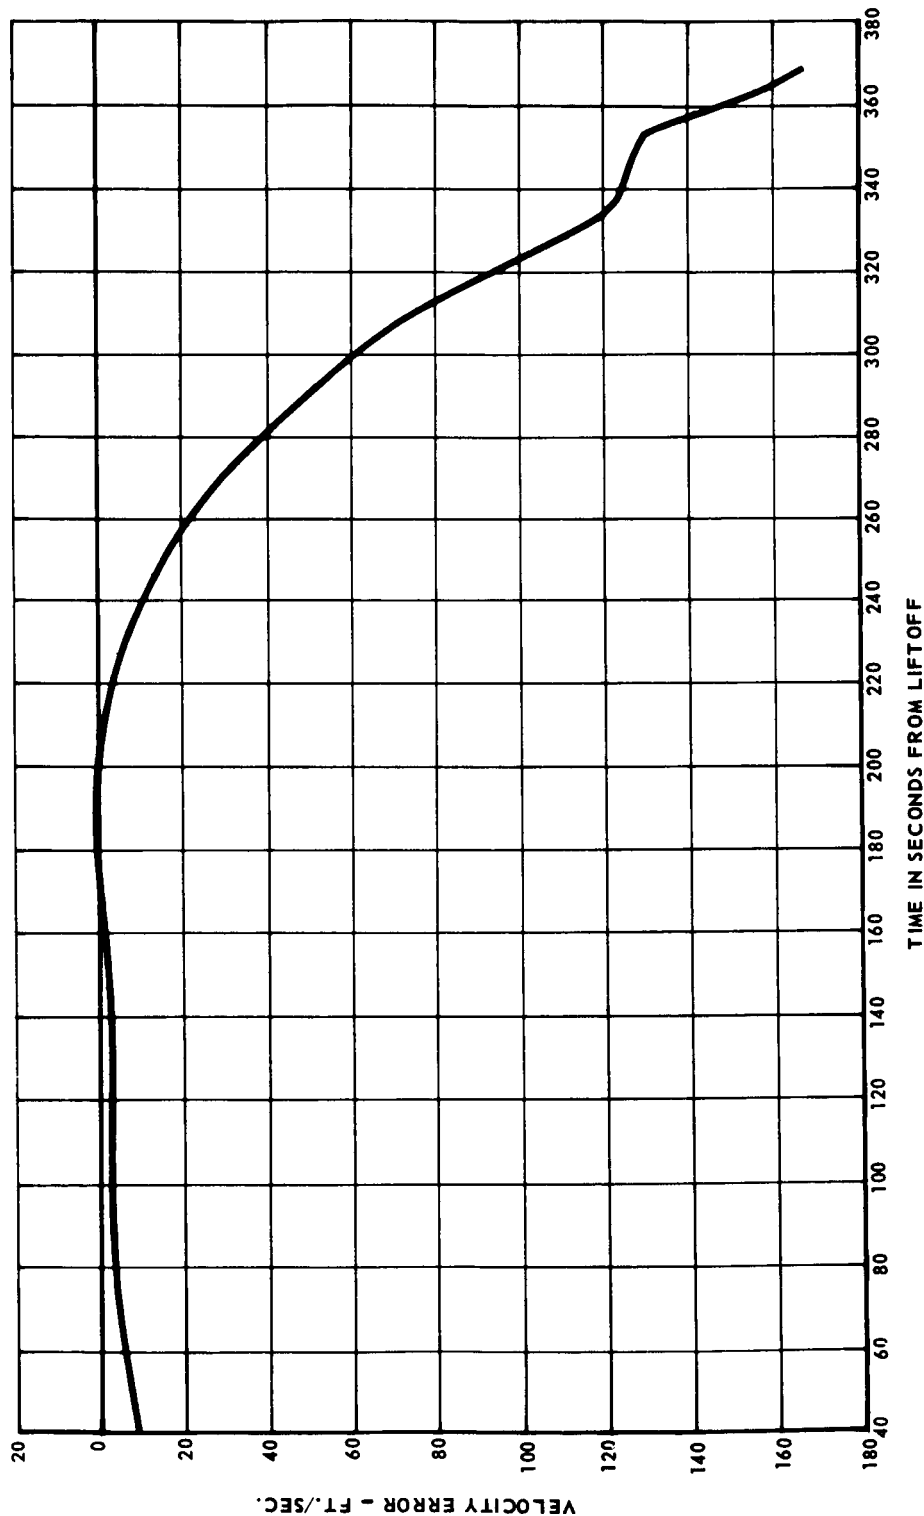
FIGURE 2

GT-3
COMPUTER Y AXIS VELOCITY ERROR VS. TIME

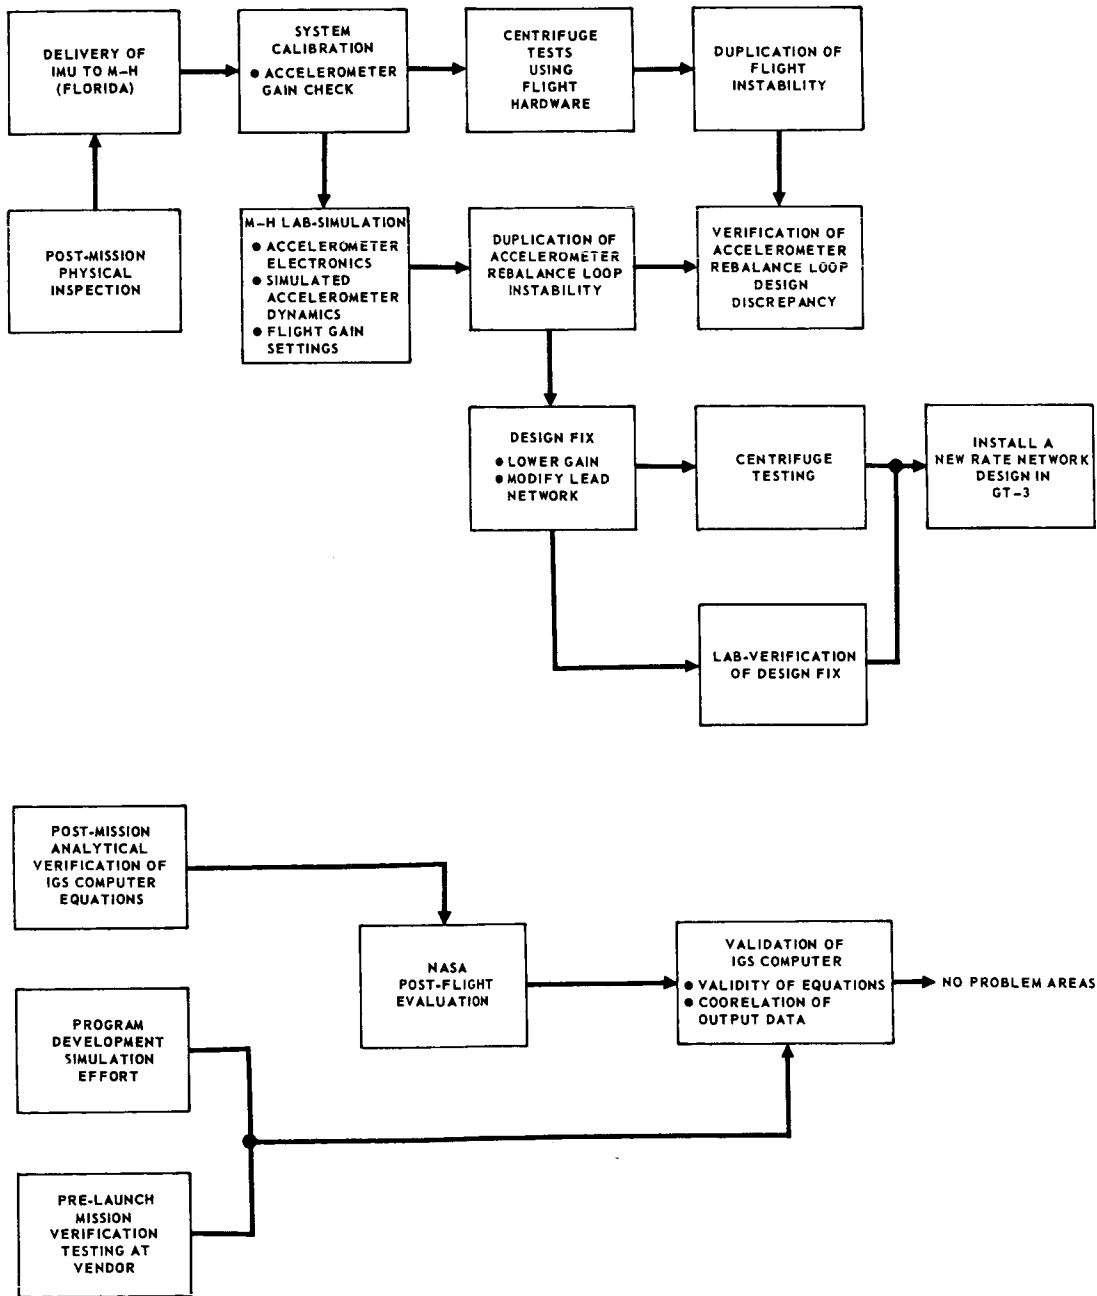
FIGURE 3

GT-2 ANOMALY INVESTIGATION PLAN

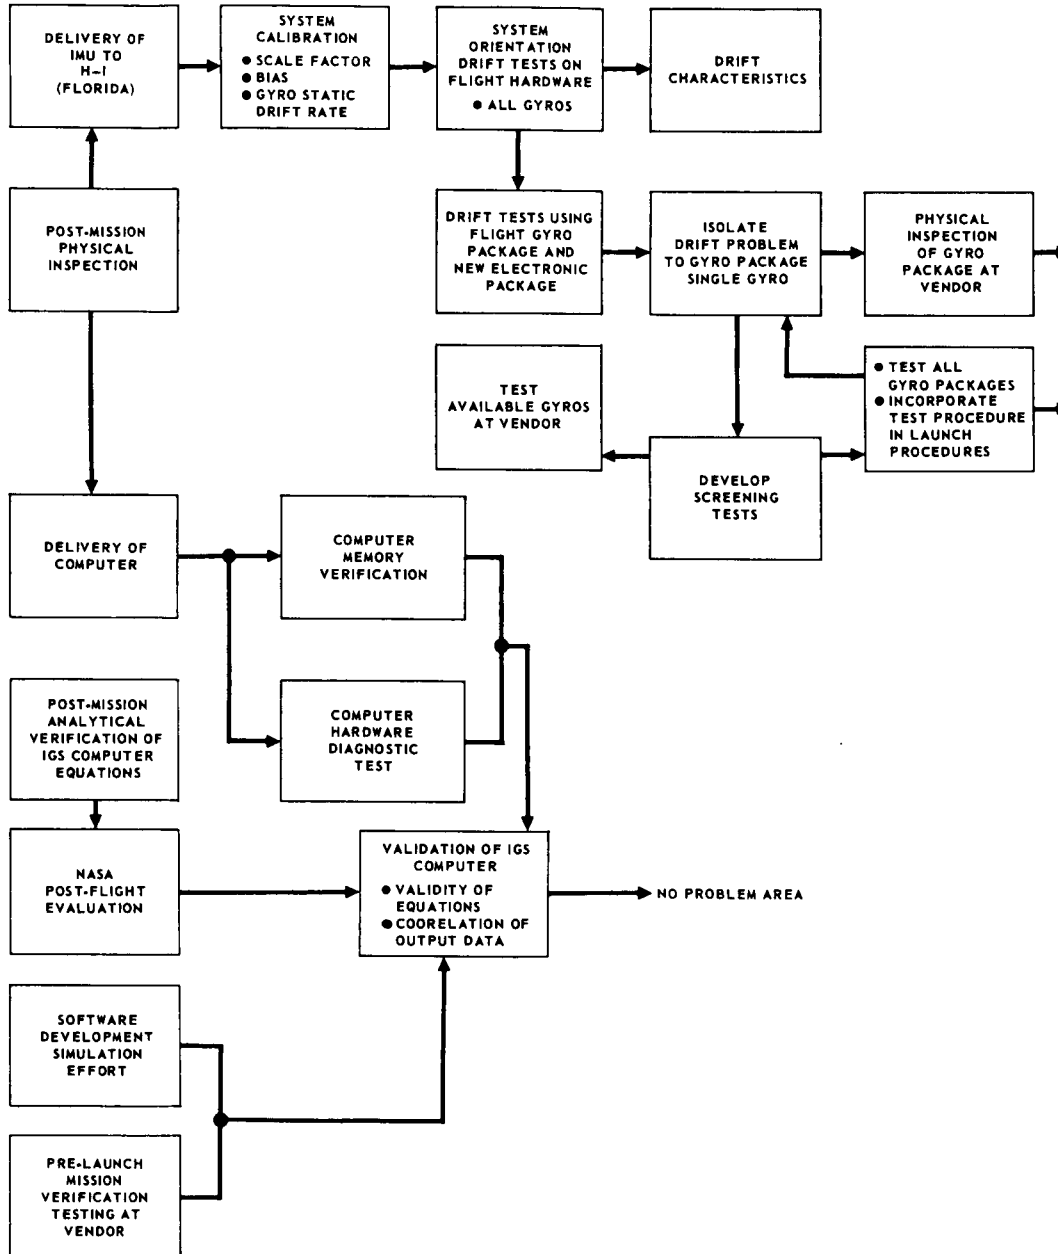
FIGURE 4

3.2 GT-3 Investigation Plan.- Post mission evaluations indicated that the causes of the GT-3 anomaly were IMU malfunctions. The Computer and IMU were returned to their respective vendors for testing. Figure 4 shows a block diagram of the GT-3 investigation plan.

3.2.1 Post Flight Physical Inspection.- All IMU units and the Computer experienced some salt water corrosion, but were operational.

GT-3 ANOMALY INVESTIGATION PLAN

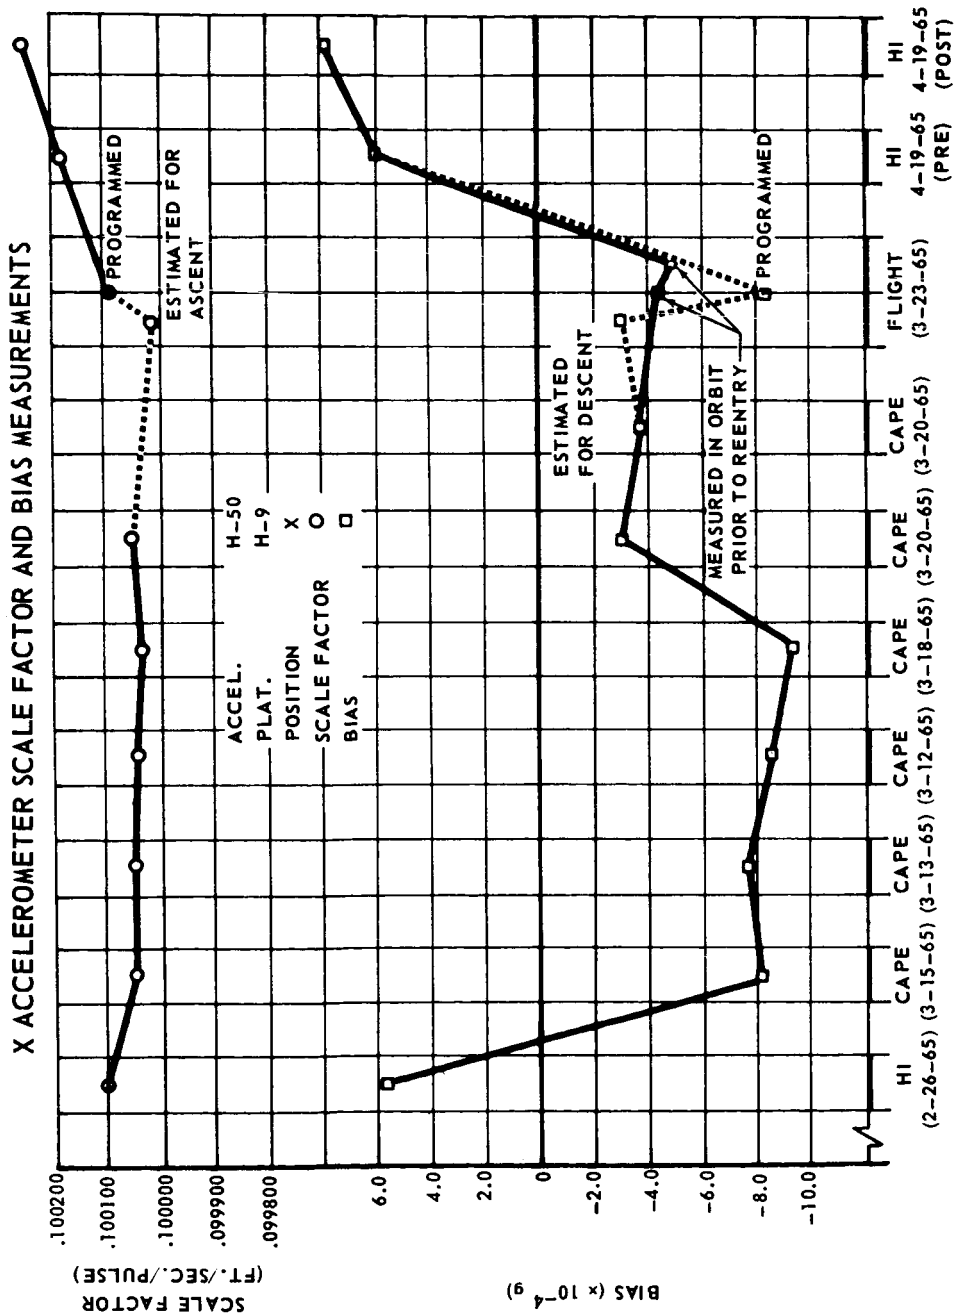
FIGURE 7

4.2.2.2 X Accelerometer Anomaly.-- Tests on the X accelerometer in the S/C #3 platform verified it as a significant contributor to the longitudinal velocity error. A history of the X accelerometer scale factor and bias measurements are presented in Figure 7. A portion of the shifts noted on Figure 7 can be attributed to differences in cabling between Honeywell and the Cape; however, some variance is due to instability in the X accelerometer pulse rebalance loop. Tests at the vendor verified the instability. This loop was modified to correct an acceleration sensitive error noted during GT-2 flight. After incorporation of the modifications for GT-3, further refinements were included effective S/C #4 and up. The latest accelerometer loop modification has eliminated the GT-3 stability problems.
